## **Historic Structure Assessment for Building 839, Carlisle Barracks**

Carlisle, Pennsylvania

October 2017

Final report

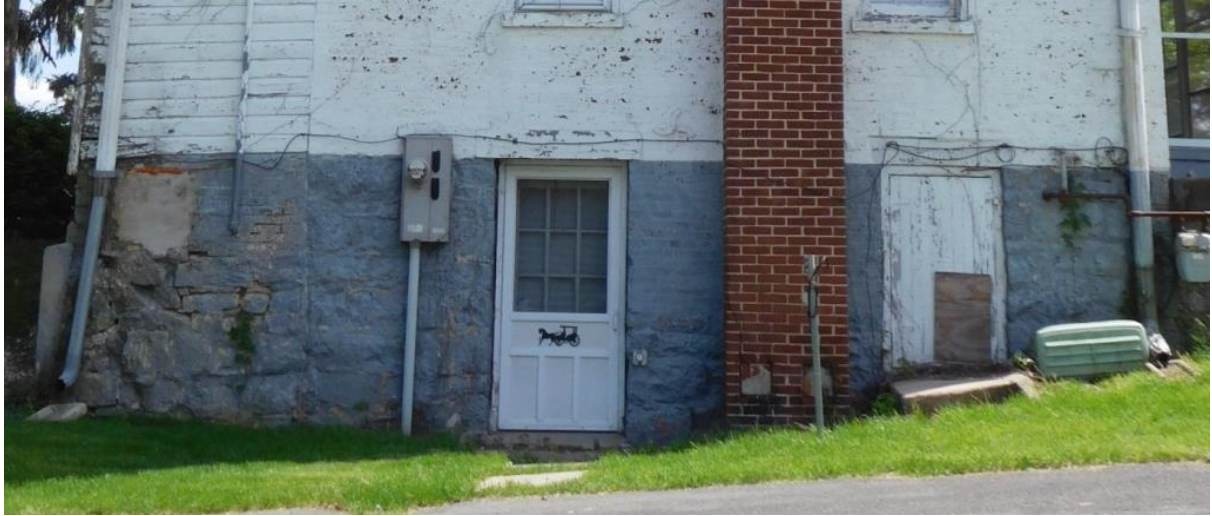
<p>The exposed stone foundation walls on the north elevation with a painted finish. (Photo: HPTC, 5/2/17)</p>

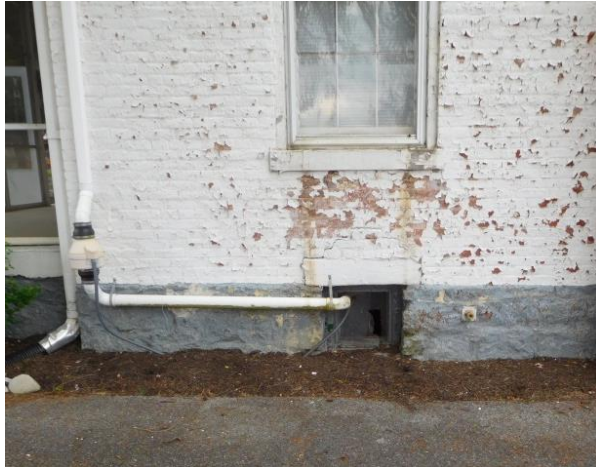
The stone foundation wall on the west elevation of the main block is painted gray.  
(Photo: HPTC, 5/2/17)

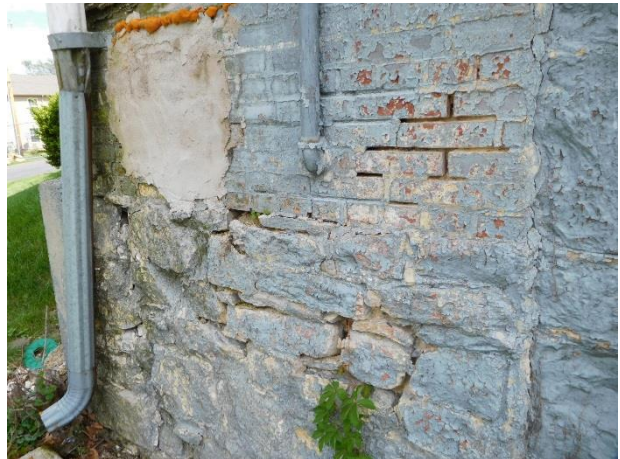
The southwest corner of the ell foundation has concrete and brick patches and missing mortar joints.  
(Photo: HPTC, 5/2/17)

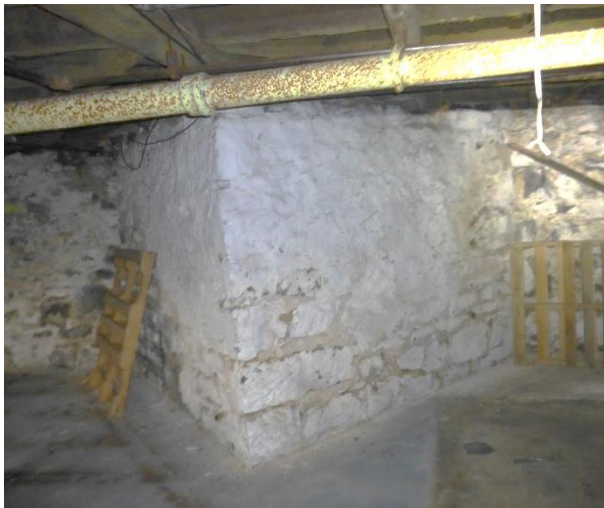
Whitewashed masonry main block foundation and triangular west elevation chimney foundation.  
(Photo: CERL, 5/2/17)

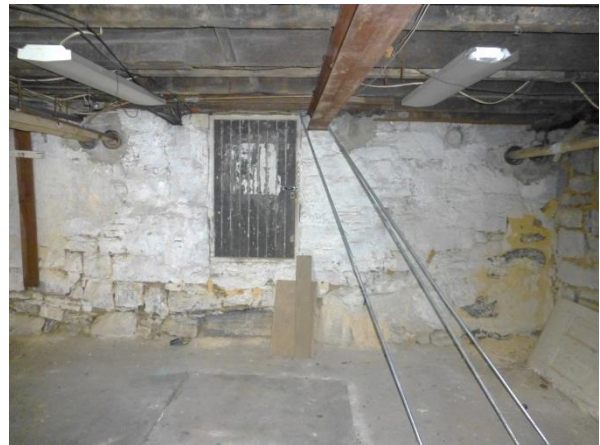
South stone foundation wall in the basement of Unit B (Room 003), with access door to crawlspace (Room 002).  
(Photo: CERL, 5/2/17)

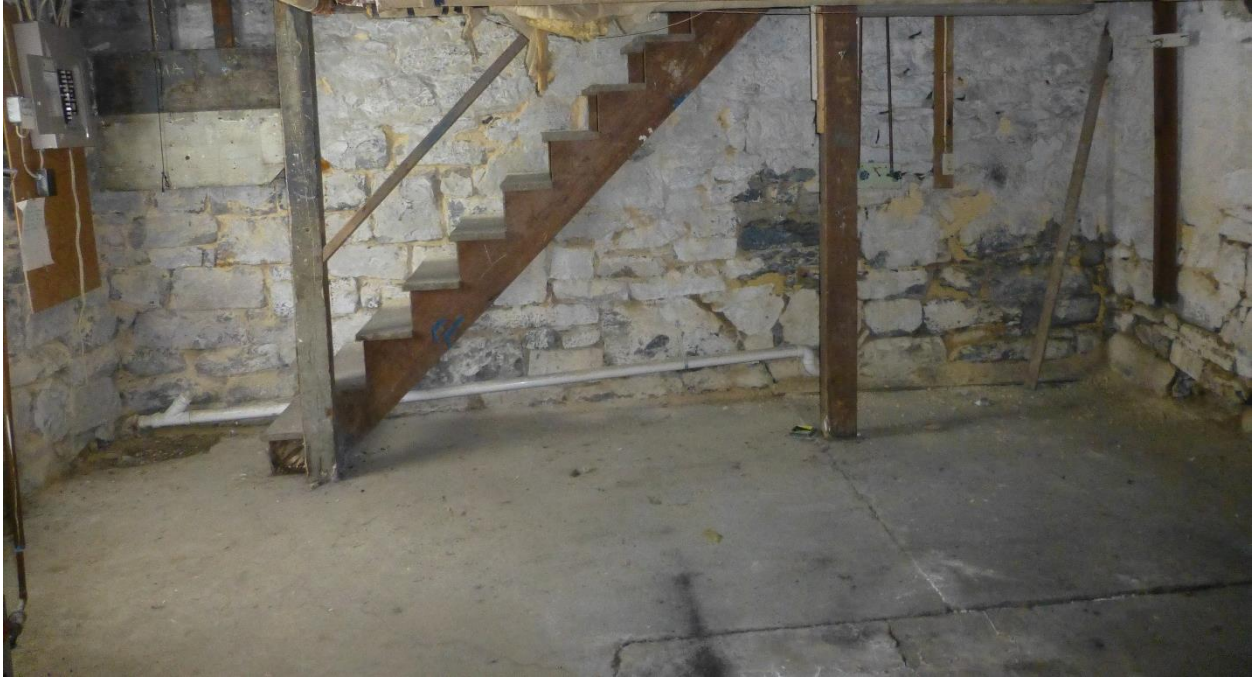
Unfinished concrete slab on grade in the basement of Unit B (Room 003).  
(Photo: CERL, 5/2/17)

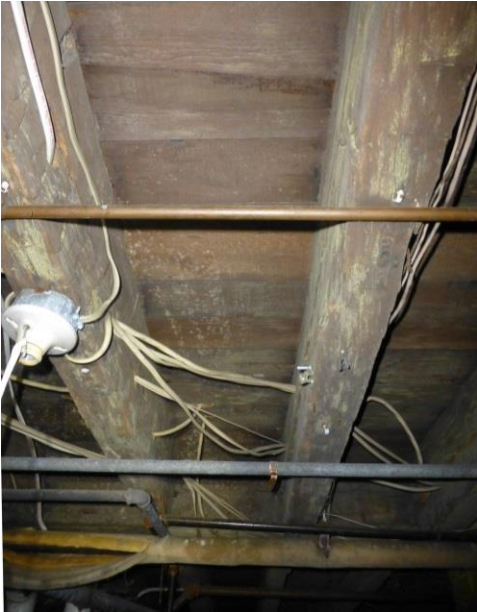
<b>B</b>	<b>SHELL</b>
<b>B10</b>	<b>SUPERSTRUCTURE</b>
	<b>B1010 Floor Construction</b>
<p>The structural floor frame on the first floor of the main block (Unit A) is composed of 4" x 9" hewn joists spaced at 18" on-center supported by a 9" x 11" summer beam. Joists run east-west.</p> <p>The first-floor structural floor frame in the ell addition (Unit B) above the basement crawlspace (Room 002) is composed of 2½" x 8" joists spaced at 16" on-center running east-west. A 6' x 6" wood beam running north-south is supported by three 6" x 6" wood posts on stone piers.</p> <p>The first-floor structural floor frame in the ell addition (Unit B) above Room 003 is composed of random-sized joists spaced at approximately 16" on-center with cross bracing. The joists are supported by a 6" x 6¾" bolted steel U-channels running.</p> <p>The floor frame is in good condition with some insect damage on select joists in the main block. The second- and third-floor structural floor frames in the main block and ell were not accessible but appear to be in good condition with no evidence of deflection in the floors.</p> <p>The south entry porch has a modern concrete floor in good condition, which likely replaced a wood-framed floor. The west porch has a wood frame floor in fair condition.</p>

<p>First-floor structural floor frame of the main block (Unit A) above Room 001. (Photo: CERL, 5/2/17)</p> </div> <div style="text-align: center;">

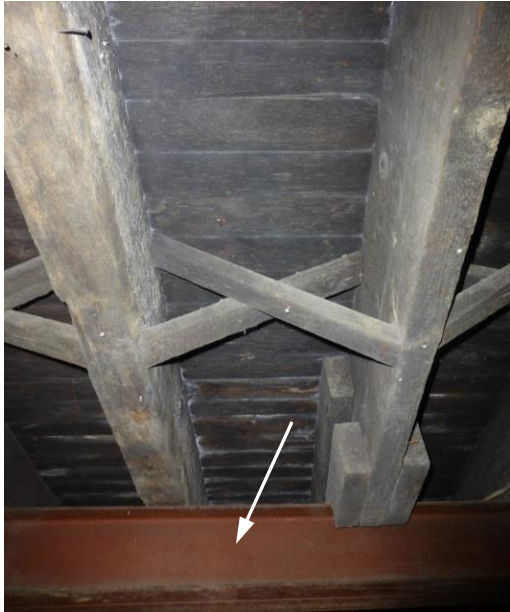
<p>First-floor structural floor frame of the ell addition (Unit B) above Room 003. Bolted U-channels (arrow) support the joists. (Photo: CERL, 5/2/17)</p> </div> </div>

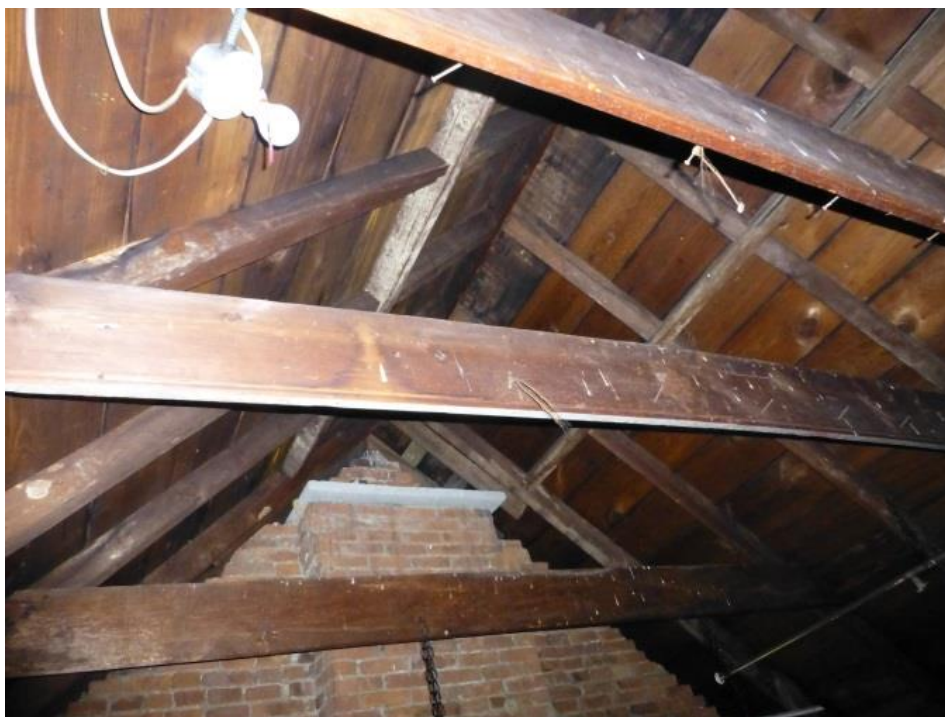
Structural roof framing in the main block, visible in Room 302.  
(Photo: CERL, 5/2/17)

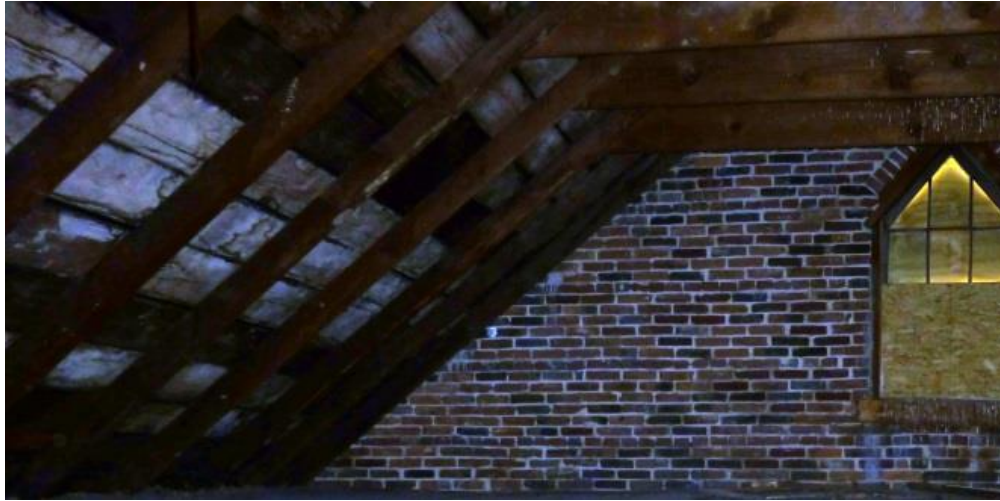
Structural roof framing in the ell addition, visible in Room 305.  
(Photo: CERL, 5/2/17)

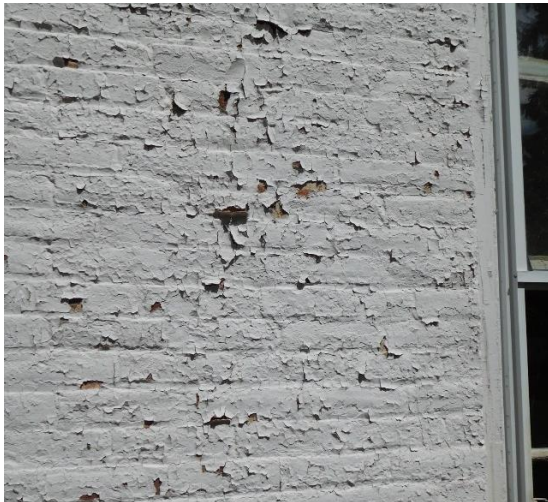
<b>B20</b>	<b>EXTERIOR ENCLOSURE</b>
	<b>B2010 Exterior Walls</b>
	<b>B201001 Exterior Skin</b>
The exterior skin of the main block and ell addition consist of painted brick masonry in fair condition. The walls have extensive paint failure; however the bricks and mortar joints are solid.

Typical brick masonry wall with failing paint. (Photo: HPTC, 5/2/17)

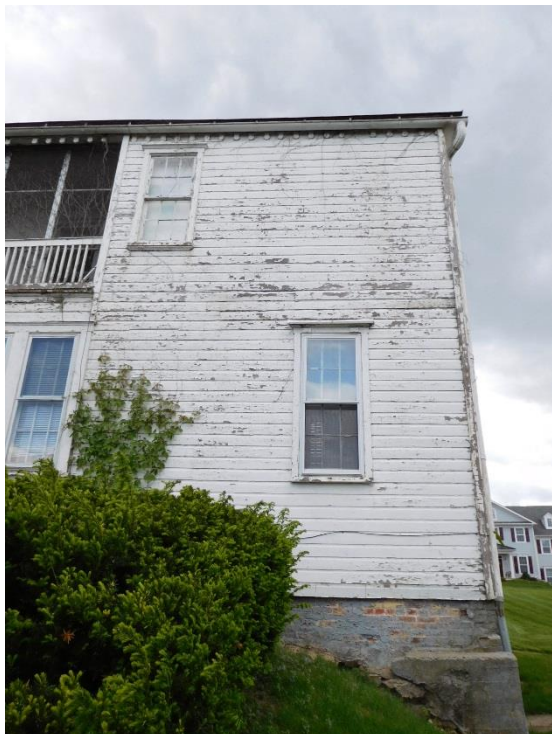
The exterior walls on the north and east elevations of the ell addition consists of painted wood novelty siding with painted wood trim. The siding is in poor condition with extensive paint failure and some deteriorated boards.

East elevation of the ell addition with painted wood novelty siding.  
(Photo: HPTC, 5/2/17)

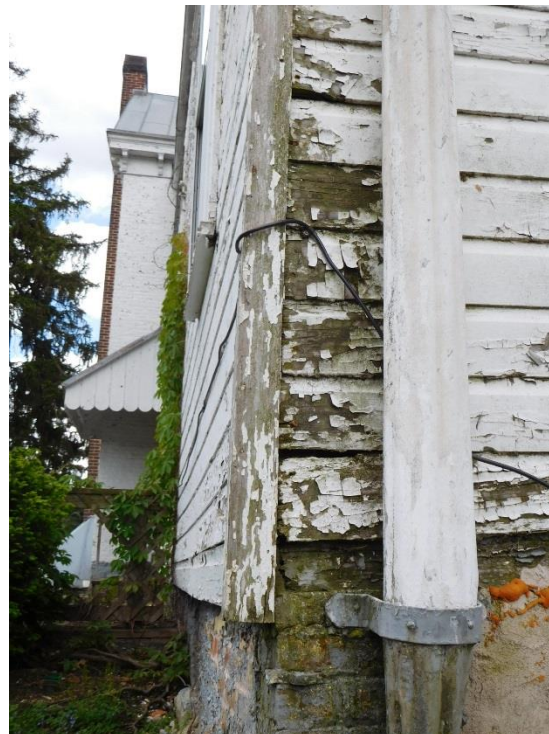
Paint failure and deterioration at the northeast corner of ell addition.  
(Photo: HPTC, 5/2/17)

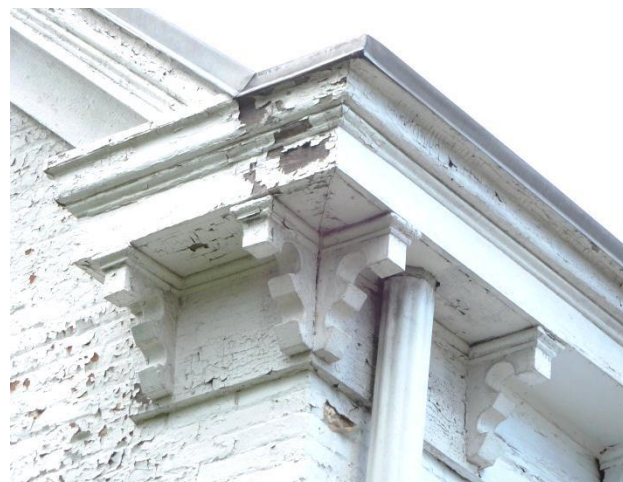
Generally the exterior wood trim is in poor condition with some missing components, deterioration, and extensive paint failure. The ell addition balcony railing has extensive paint failure and related deterioration.

Wood cornice and brackets on the main block.  
(Photo: HPTC, 5/2/17)

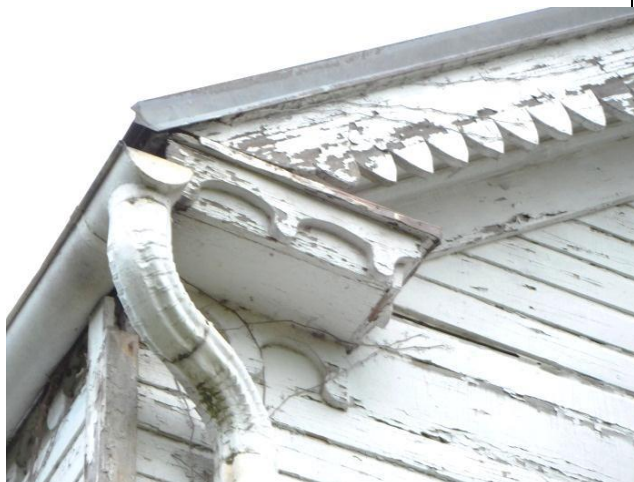
Fascia and cornice returns on the north elevation of the ell addition.  
(Photo: HPTC, 5/2/17)

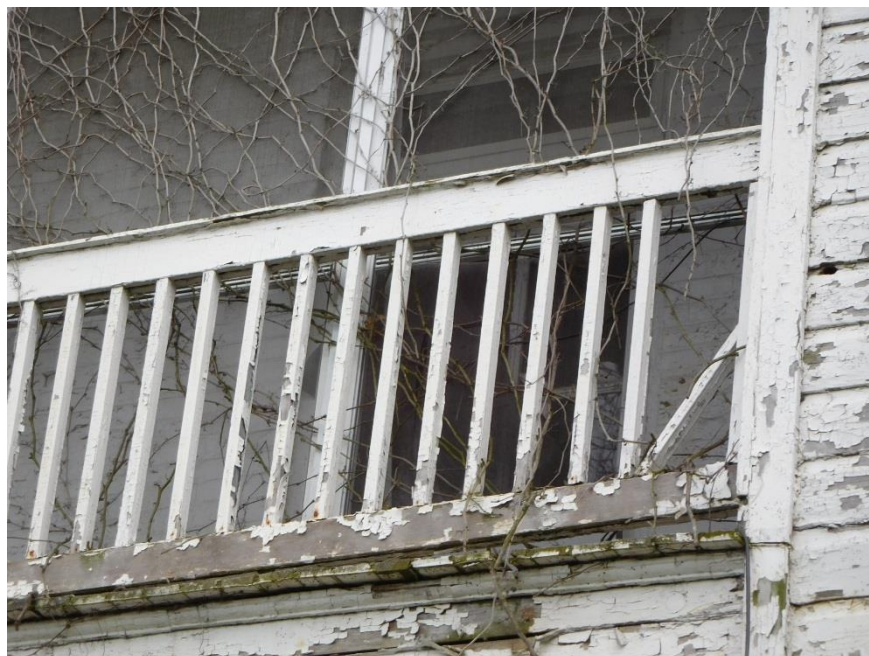
The second-floor balcony railing on the east elevation of the ell addition has damaged wood components and significant paint failure.  
(Photo: HPTC, 5/2/17)

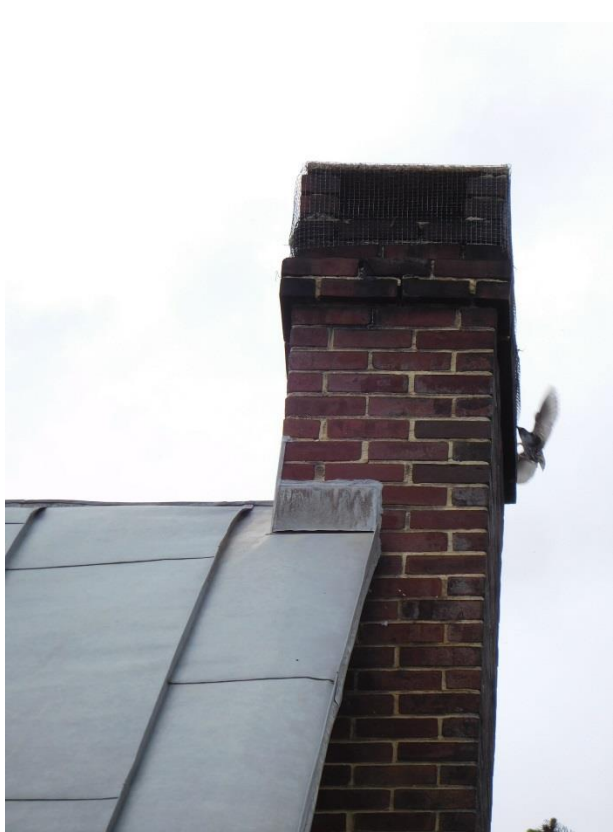
Generally the chimneys are in fair condition with some loose or missing mortar, moderate staining, and loose flashing.

East chimney on the main block.  
(Photo: HPTC, 5/2/17)

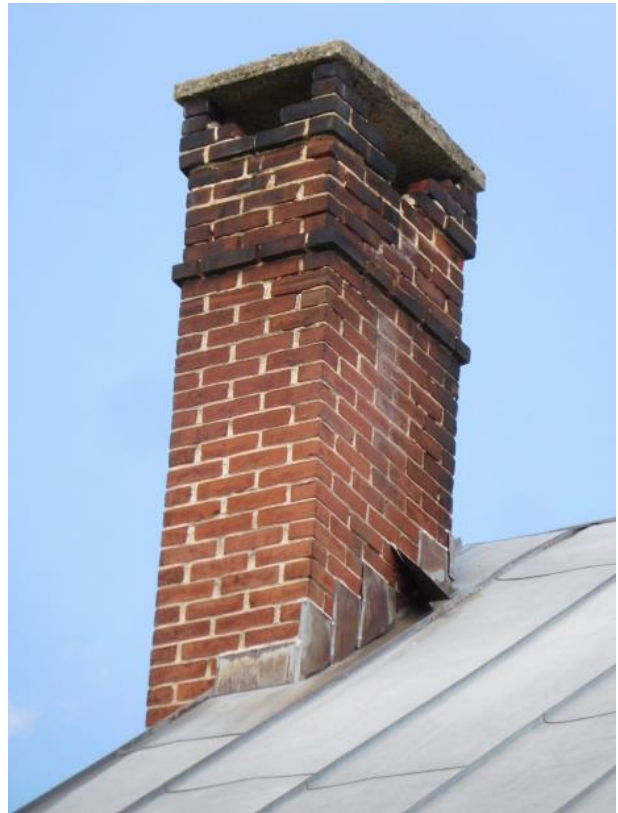
The step flashing on the north chimney on the ell addition has become loose. (Photo: HPTC, 5/2/17)

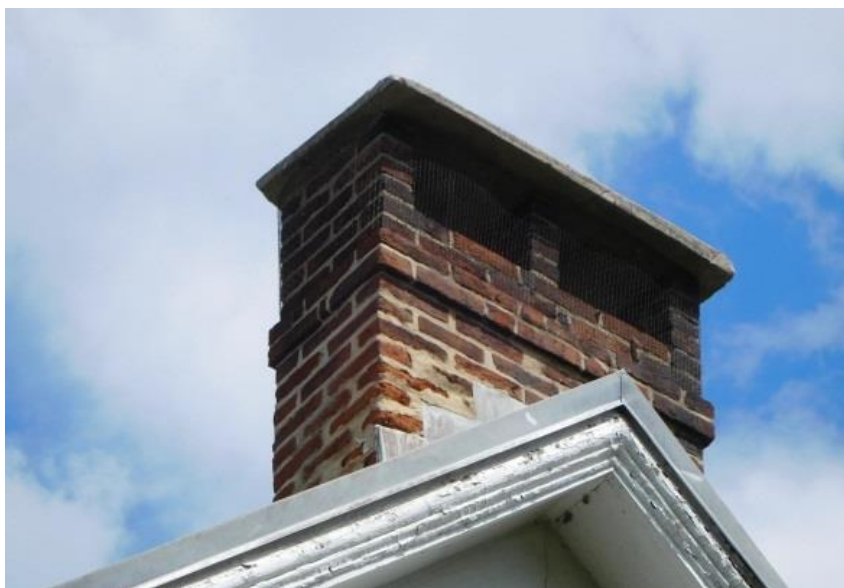
Interior chimney on the west gable end of the main block. (Photo: HPTC, 5/2/17)

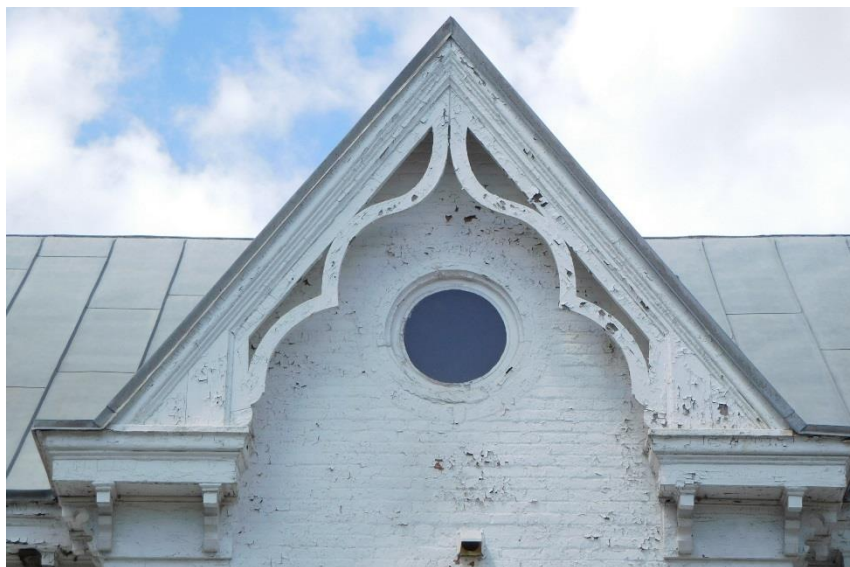
The windows are in poor condition overall, with significant glazing failure, several cracked lights and broken/missing storms, and paint failure on sash, jambs, and sills. Several openings have been modified to accept air conditioning units. None of the openings has ventilation louvers or screens in order to provide cross ventilation within the building.

An oculus window with Plexiglas lite on the south elevation. (Photo: HPTC, 5/2/17)

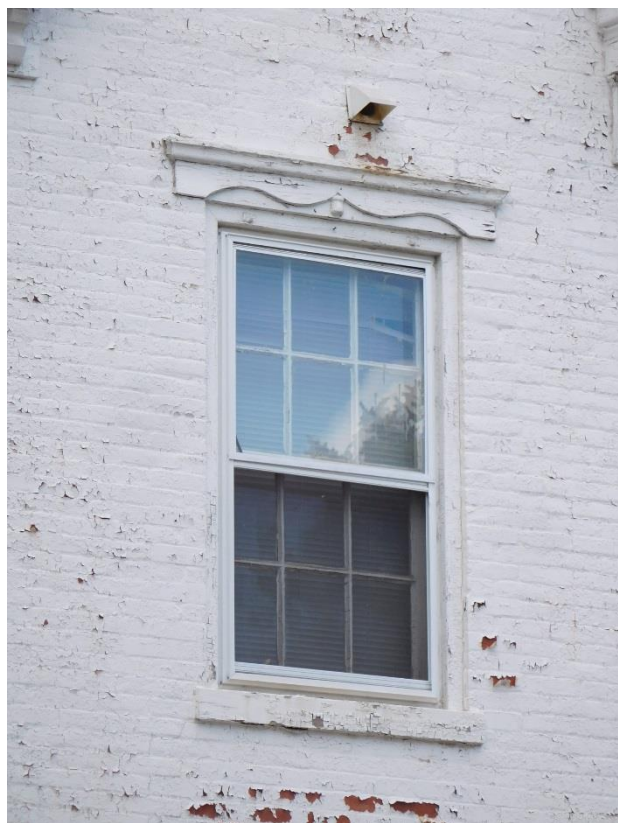
Typical historic wood 6-over-6 double-hung window on the south elevation with a decorative hood and an exterior storm unit. (Photo: HPTC, 5/2/17)

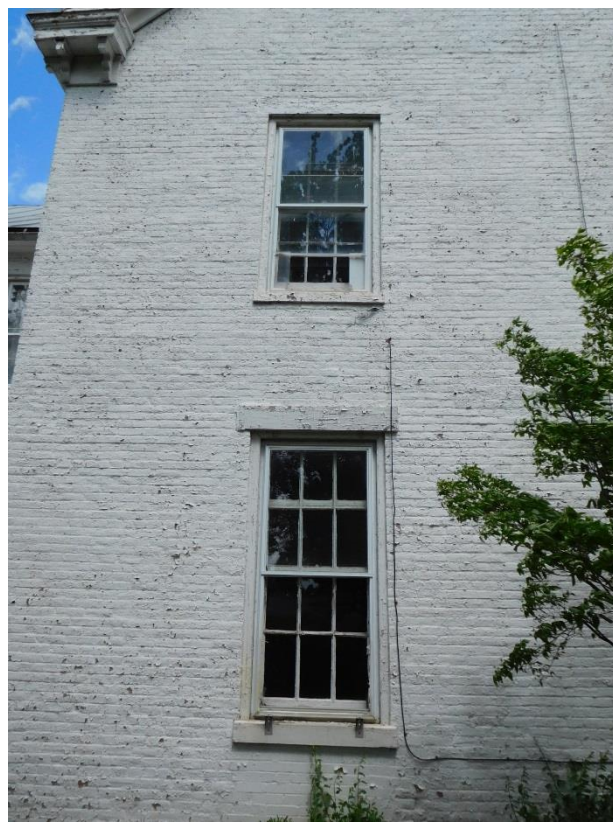
Typical windows on the west elevation of the main block with plain wood lintels and sills. (Photo: HPTC, 5/2/17)

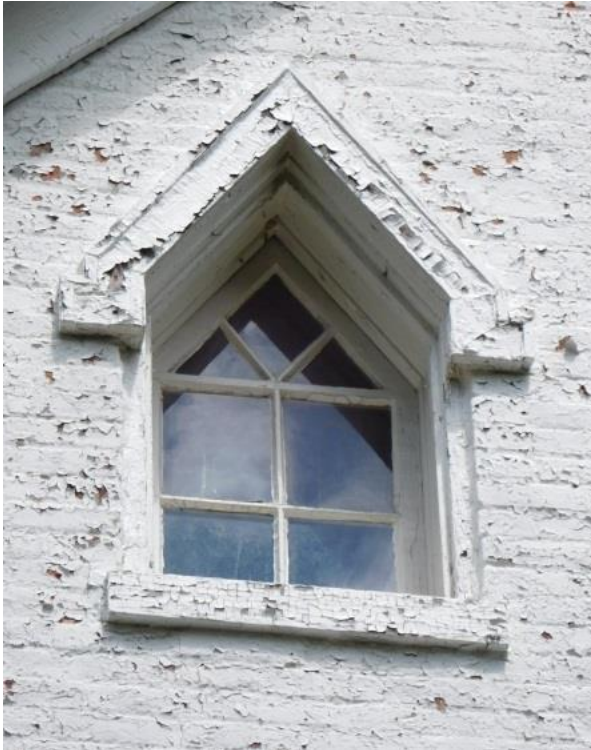
Typical pentagonal window in the gable ends of the main block. (Photo: HPTC, 5/2/17)

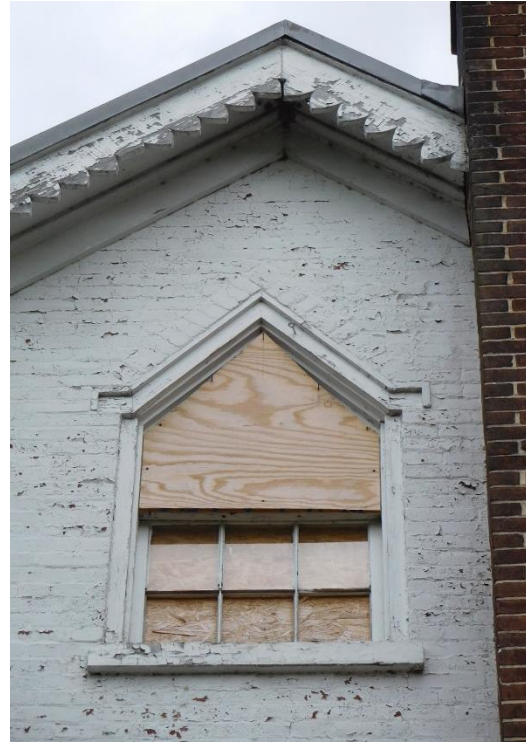
A variant of the pentagonal window in the gable end on the south elevation of the ell addition. (Photo: HPTC, 5/2/17)

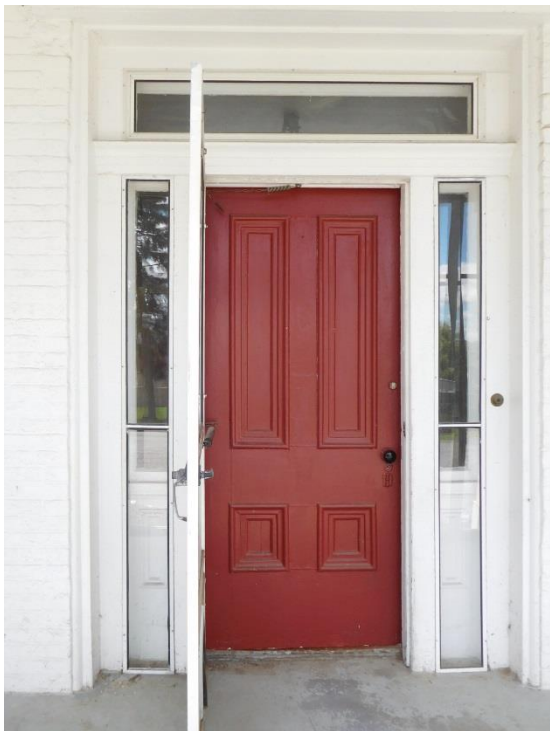
Front door (D101) on the south elevation.  
(Photo: HPTC, 5/2/17)

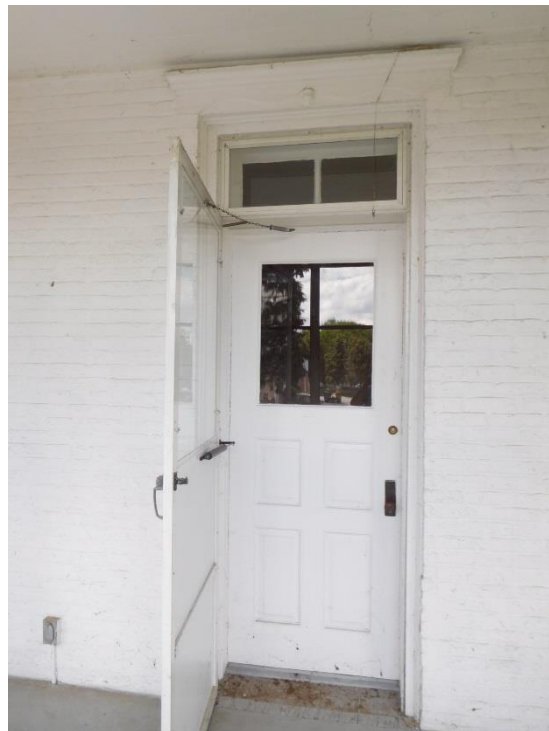
Front door (D102) on the south elevation.  
(Photo: HPTC, 5/2/17)

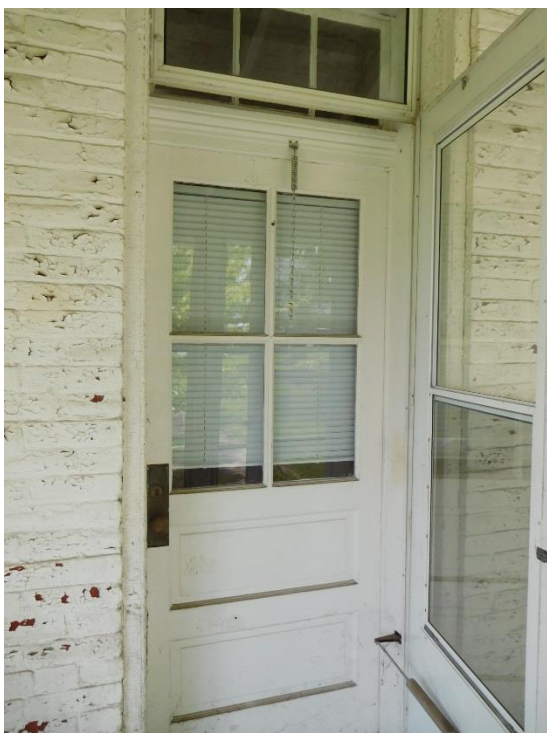
West porch door (D106) on the west elevation.  
(Photo: HPTC, 5/2/17)

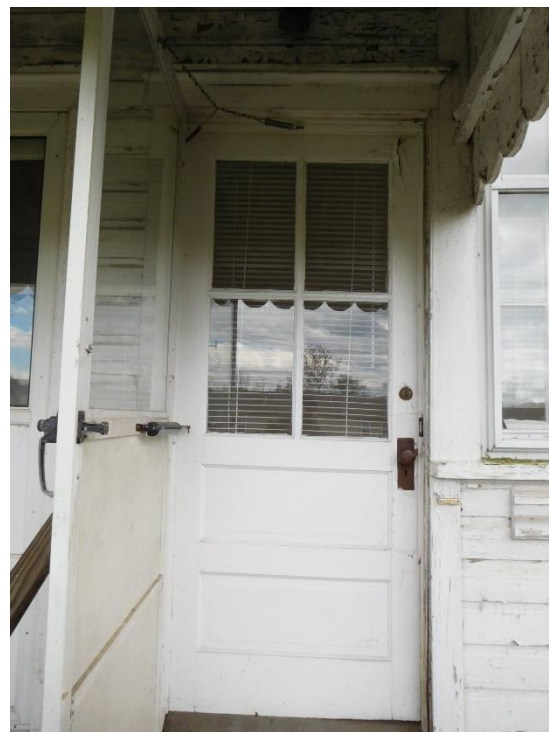
One of two identical doors (D103, D104) on the east elevation. (Photo: HPTC, 5/2/17)

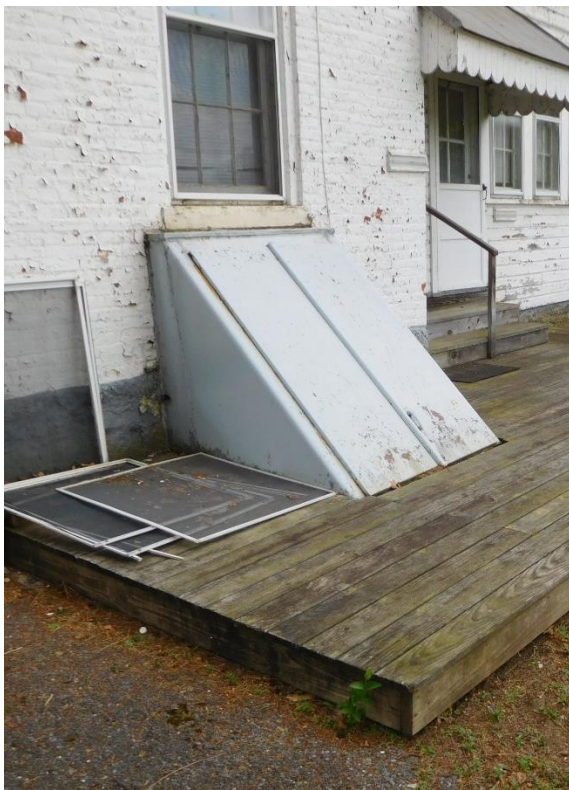
Steel basement access doors on the east elevation.  
(Photo: HPTC, 5/2/17)

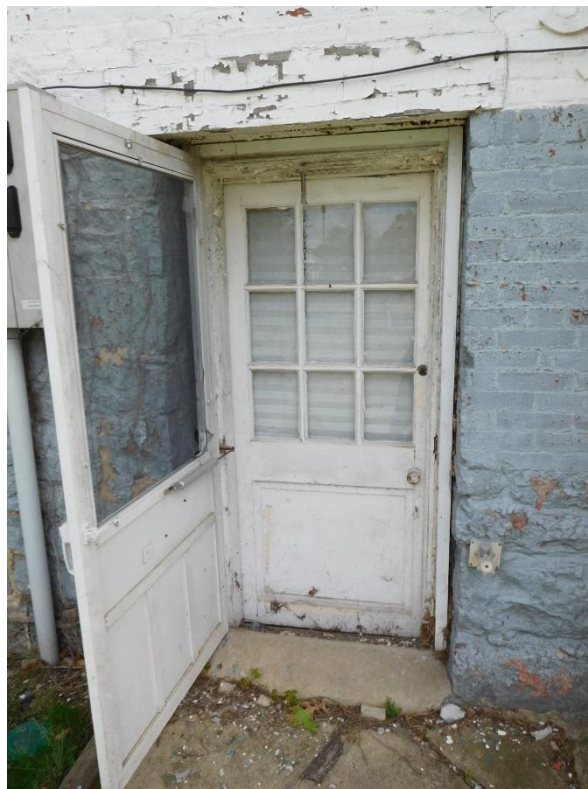
Basement door (D002) on the north elevation.  
(Photo: HPTC, 5/2/17)

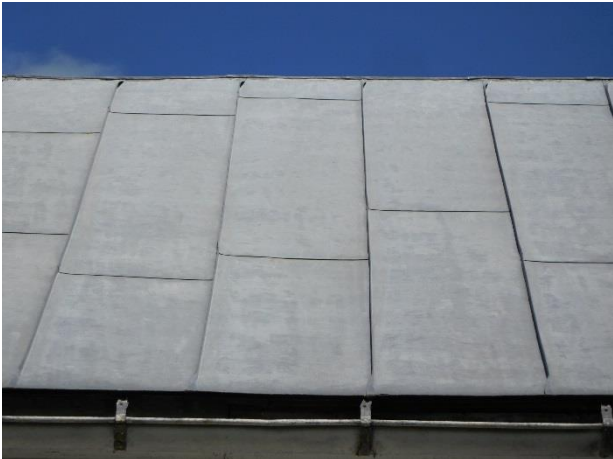
<b>B30</b>	<b>ROOFING</b>
		<b>B3010 Roof Coverings</b>
		<b>B301001 Roof Finishes</b>
<p>The finish on the roofs of the main block, ell addition, and west elevation porch is standing seam metal roofing. The south porch and east elevation entrance roofs are flat seam metal. Sheathing consists of ¾" x 9¾" boards in the main block and a combination of 3¼" tongue-and-groove and 10" standard boards in the ell addition.</p> <p>Overall, the roofing systems are in good condition, with one damaged area on the south porch roof.</p>		
<div style="display: flex; justify-content: space-around;"> <div style="text-align: center;">

<p>Typical standing seam metal roof. (Photo: HPTC, 5/2/17)</p> </div> <div style="text-align: center;">

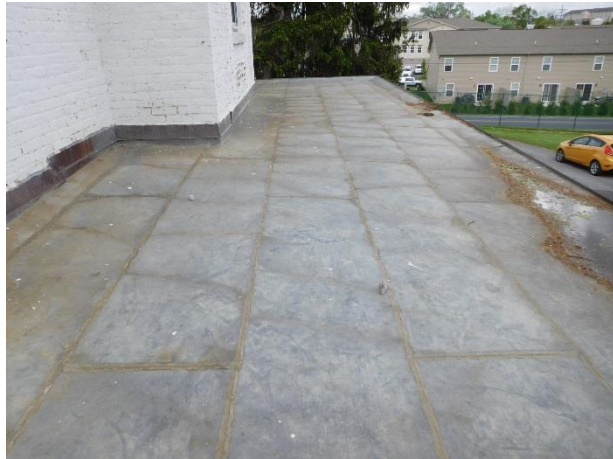
<p>Flat seam metal roof on the south porch. (Photo: HPTC, 5/2/17)</p> </div> </div>		
		<b>B301001 Roof Finishes</b>
	Qualitative Condition Rating	GOOD
	Maintenance Deficiency Rating	MINOR

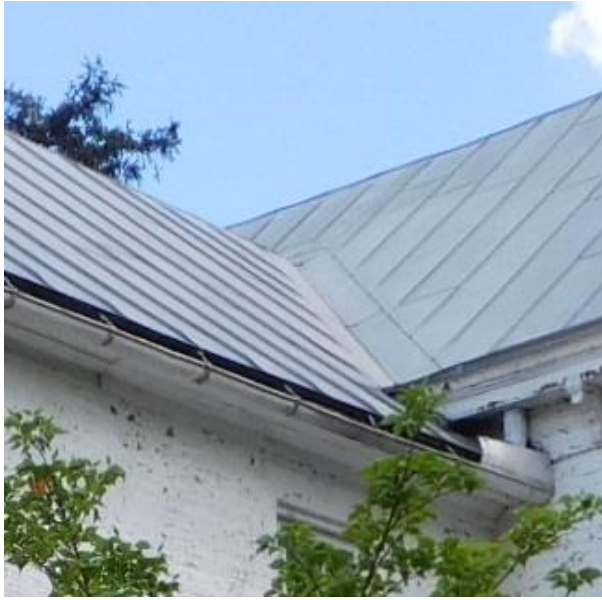
<b>B301004 Flashing and Trim</b>
<p>The roofs and chimneys of the main block and ell addition are flashed. Overall, flashings are in fair condition, with some failure/loose components on the south elevation porch roof and the north elevation chimney.</p>

Valley flashing between the ell addition and main block roofs. (Photo: HPTC, 5/2/17)

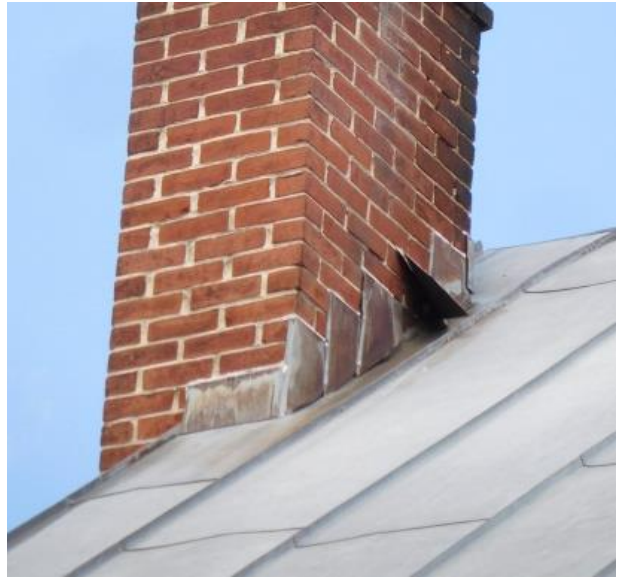
The step flashing has separated from the south chimney on the ell addition. (Photo: HPTC, 5/2/17)

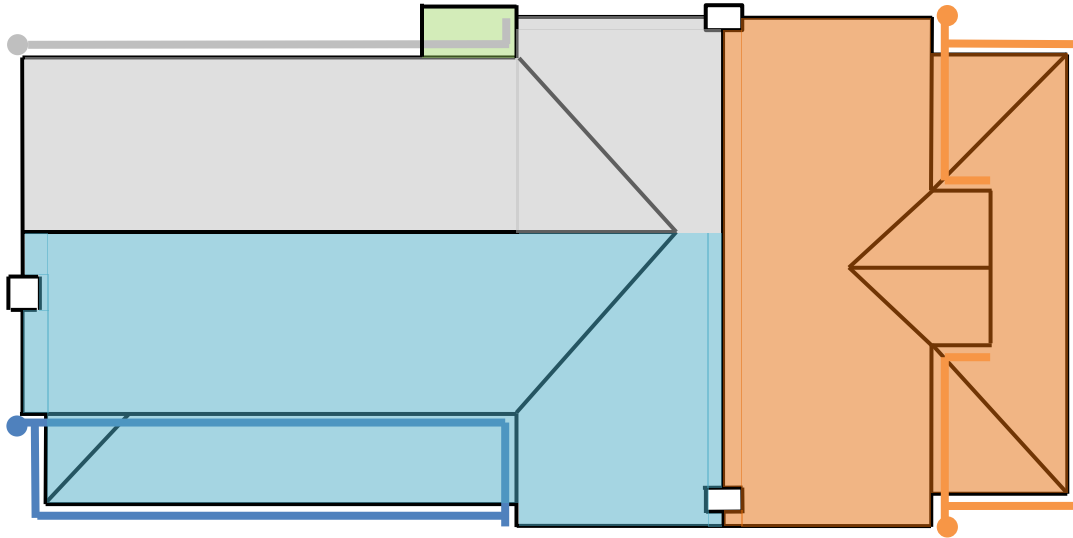
Roof plan of the various drainage zones:

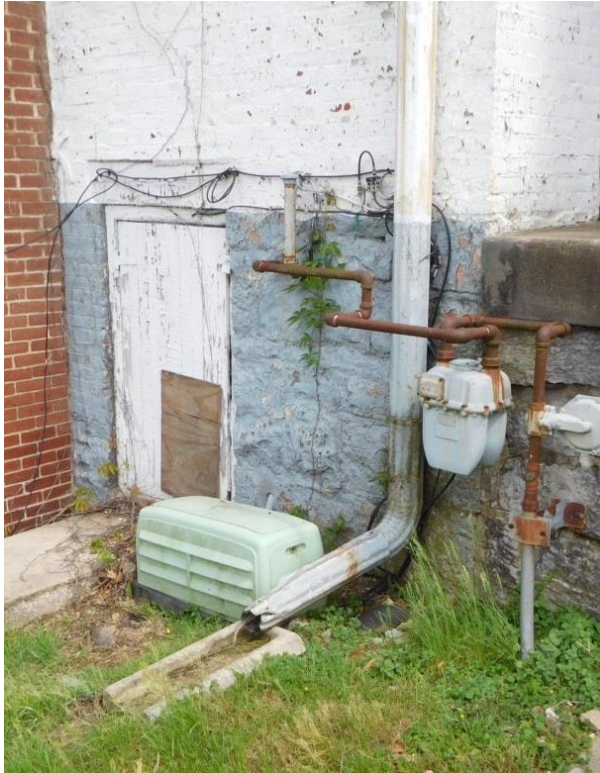
Downspout with splash pad, northwest corner of ell addition. (Photo: HPTC, 5/2/17)

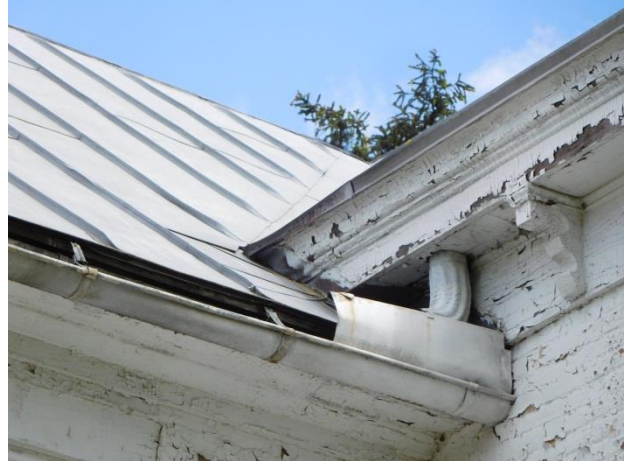
Half-round gutter on the ell addition and box gutter on the main block. (Photo: HPTC, 5/2/17)

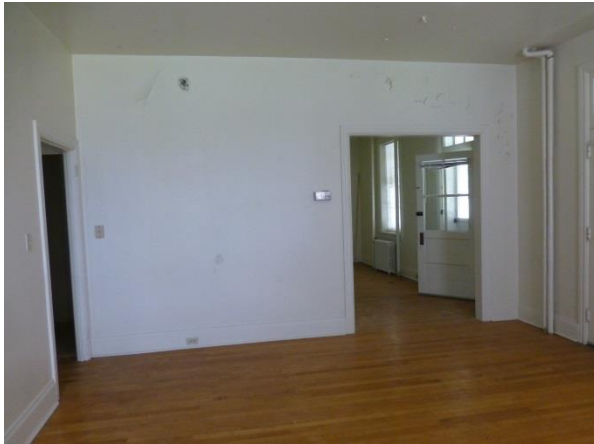
<b>C</b>	<b>INTERIORS</b>	
	<b>C10</b>	<b>Interior Construction</b>
		<b>C1010 Partitions</b>
		<b>C101001 Fixed Partitions</b>
<p>The interior fixed partitions (non-loadbearing) walls are wood frame construction and are in overall fair condition. Several modern framed partition walls in the third floor of Unit A have been vandalized and are in poor condition.</p>		
<div style="display: flex; justify-content: space-around;"> <div style="text-align: center;">

<p>Partition wall, Room 109, Unit B, first floor. (Photo: CERL, 5/2/17)</p> </div> <div style="text-align: center;">

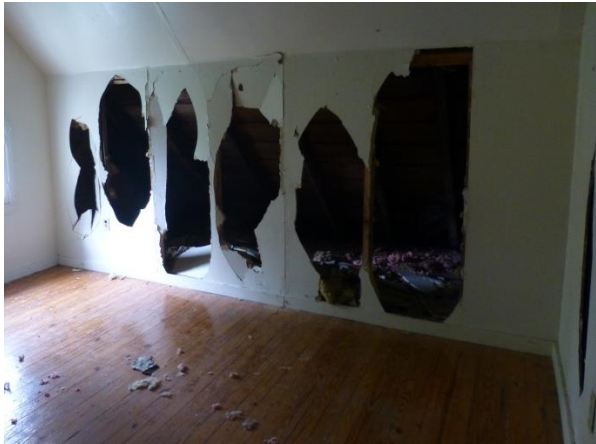
<p>Damaged partition walls in Room 304 on the third floor in Unit A. (Photo: CERL, 5/2/17)</p> </div> </div>		
<b>C101001 Fixed Partitions</b>		
Qualitative Condition Rating		FAIR
Maintenance Deficiency Rating		MINOR

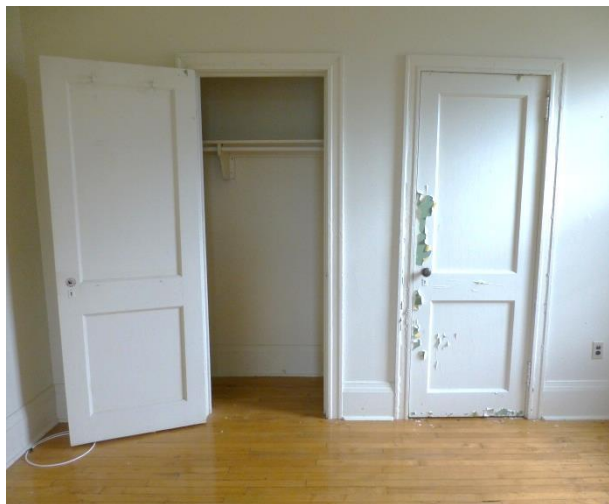
<b>C1020 Interior Doors</b>
	<b>C102001 Standard Interior Doors</b>
<p>The interior doors are painted wood with two panels and four panels and most doors are through-tenoned. All doors are original historic doors except one modern bi-fold door in the second-floor hall (Room 204) in Unit B. The historic hardware is present on most doors.</p> <p>Jamb mortises are present in several first-floor door openings where doors have been removed. Some historic doors have been stored in the attic in Unit B. Overall, the interior doors are in fair condition.</p>

Closet doors, Room 202, Unit A. Most of the closet doors in Unit A are through-tenoned. Note that one door retains its historic hardware and one does not. (Photo: CERL, 5/2/17)

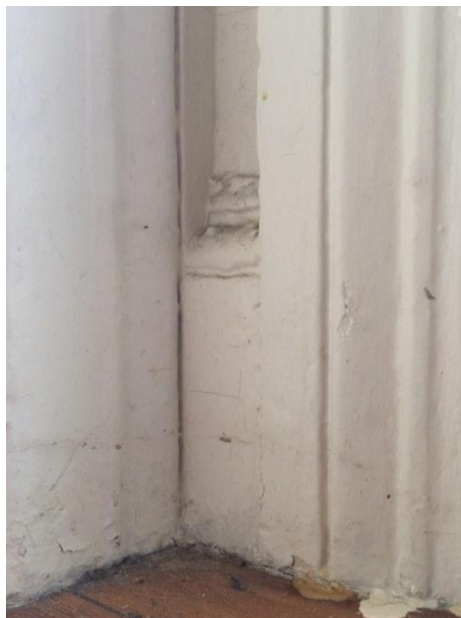
The only extant historic baseboard in Unit A is located between Doors D212 and D213.  
(Photo: HPTC, 5/5/17)

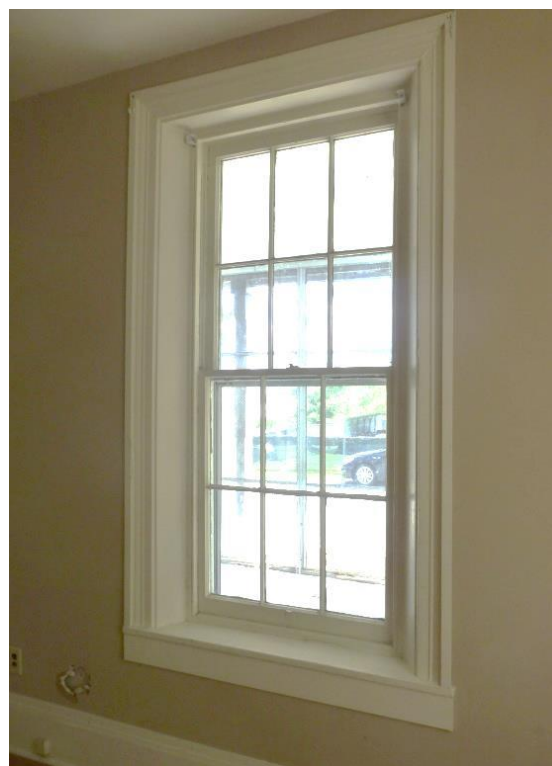
*Right:* Historic window surround, Room 112, Unit A. Non-historic strips have been added to the perimeter of window surrounds throughout the first floor of Unit A to accommodate the installation of drywall. (Photo: CERL, 5/2/17)

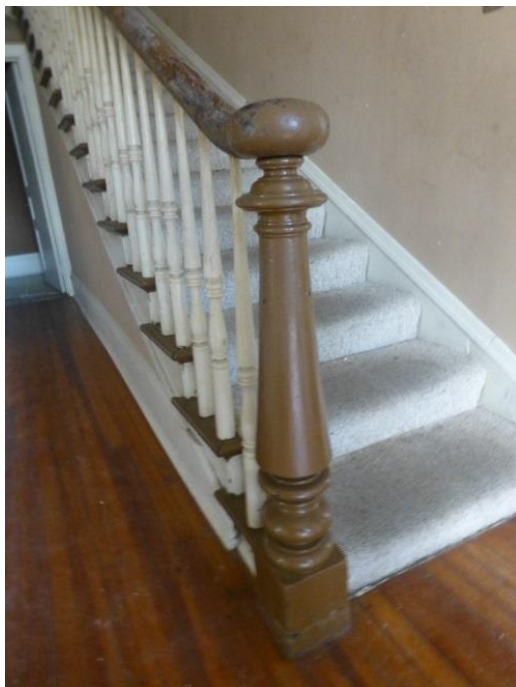
Historic newel post and balustrade on the main stairs in Unit A. (Photo: CERL, 5/2/17)

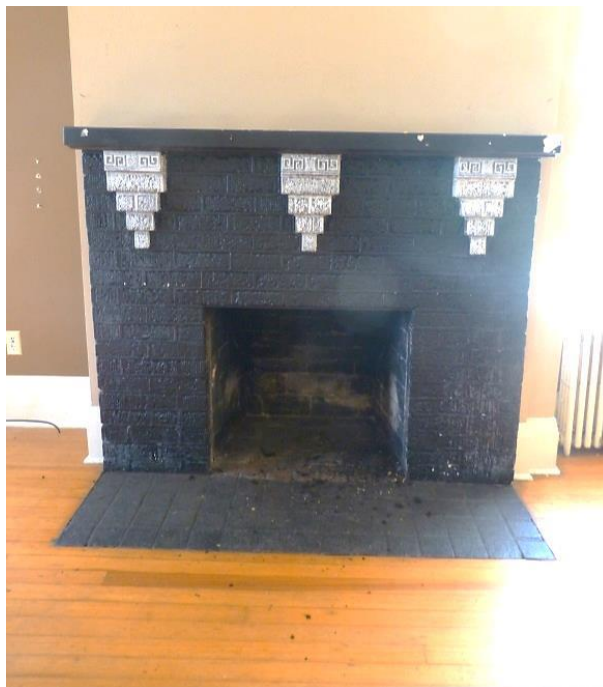
Non-historic mantel, Room 112, Unit A. (Photo: CERL, 5/2/17)

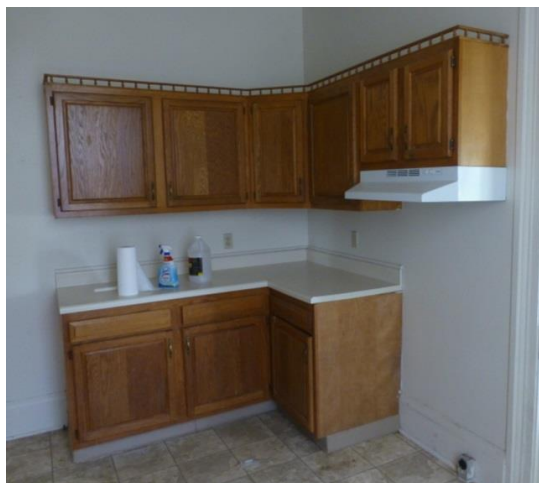
Non-historic cabinets in the kitchen (Room 103) in Unit A. (Photo: CERL, 5/2/17)

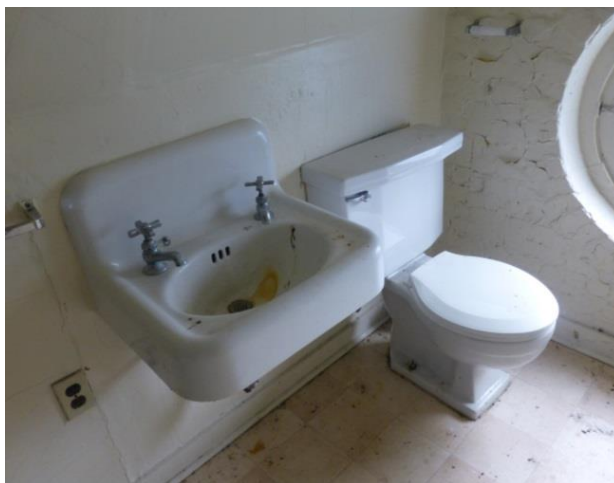
Sink and toilet in the third-floor bathroom (Room 301). The sink is the only extant historic plumbing fixture in the building, but does not date to the period of significance. Note also non-historic baseboards. (Photo: CERL, 5/2/17)

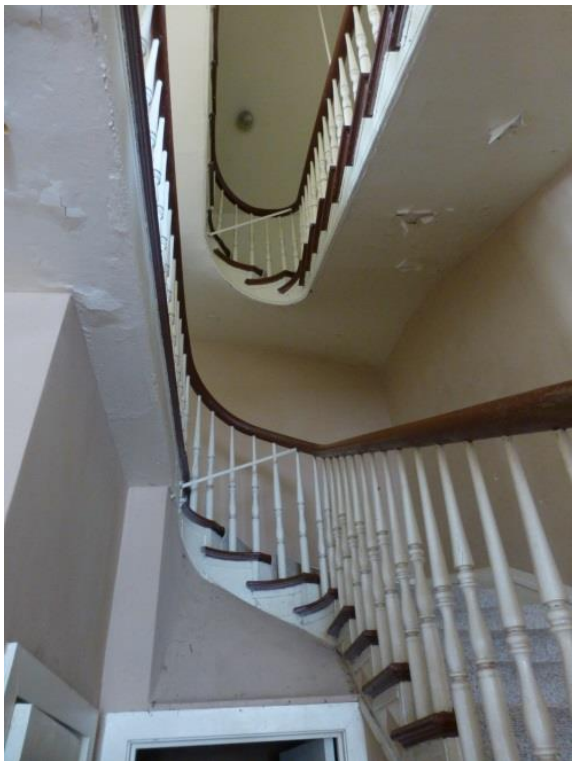
<p>Main stair, Unit A. Note metal supports. (Photo: CERL, 5/2/17)</p> </div> <div style="text-align: center;">

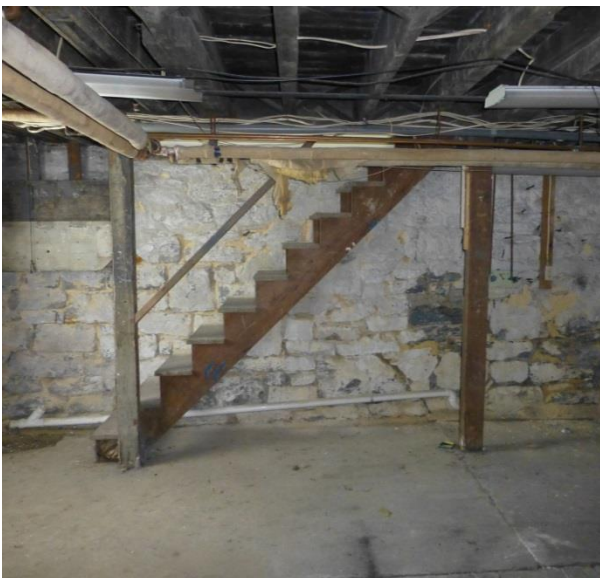
Non-historic interior basement stair, Unit B.  
(Photo: CERL, 5/2/17)

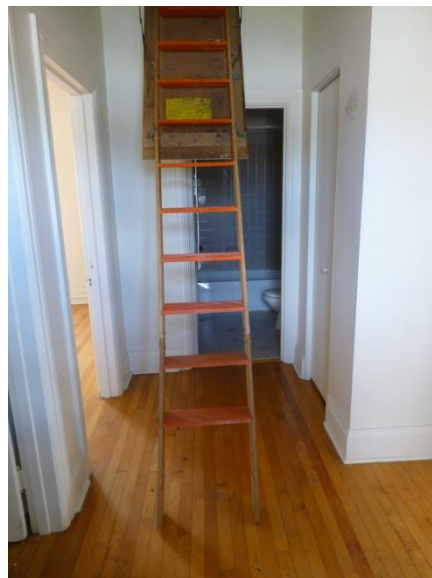
Attic access stair in Unit B (Room 204). The  
bottom tread is missing. (Photo: CERL, 5/2/17)

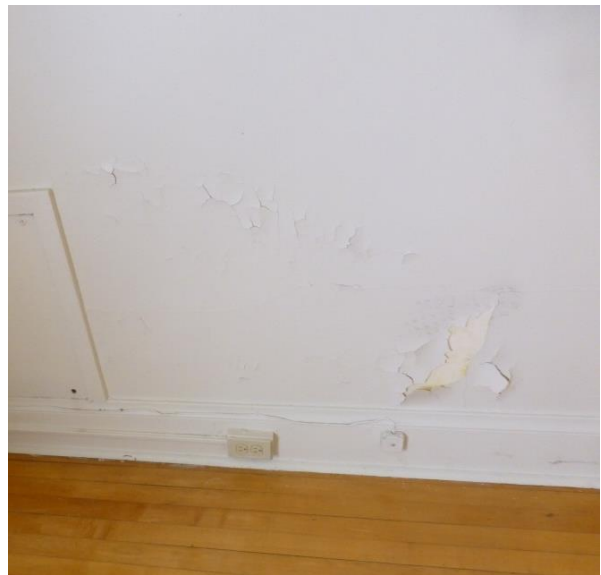
Overall, the wall finishes are in fair condition. However, both units have extensive paint failure throughout and some localized damage in locations where previous invasive materials testing was conducted. The wall damage in Rooms 304 and 305 was caused by vandalism.

Most wall finishes in Unit B are historic plaster. Note paint failure. (Photo: CERL, 5/2/17)

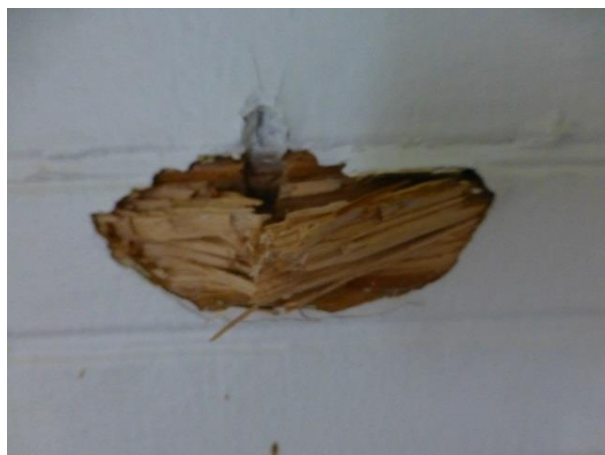
Beaded board wall finish damaged by invasive materials testing in Room 106.  
(Photo: CERL, 5/2/17)
